**Flood Control Project Maintenance
Levee Inspections****LMA District Cover Sheet****Spring 2014 Levee Inspection Results****Tehama County Flood Control and Water Conservation District**

Levee Inspection Report By Mile - Spring 2014

Tehama County Flood Control and Water Conservation District

| Waterway | Bank | Unit Miles | Inspection Start/End | Inspector |
|---|---|---|---|---|
| Unit No. 01 Deer Creek | Left | 4.11 | 03/26/2014 03/26/2014 | Bob Duffey |

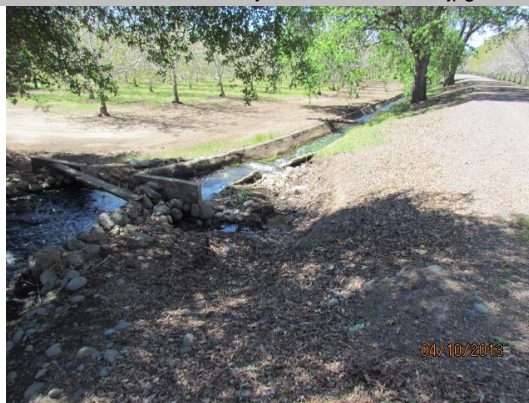
Photo 1 of 1 : rduffey_s_20140304_603.jpg

View of the erosion along the landside slope.

| Note and monitor erosion site. | | | | | |

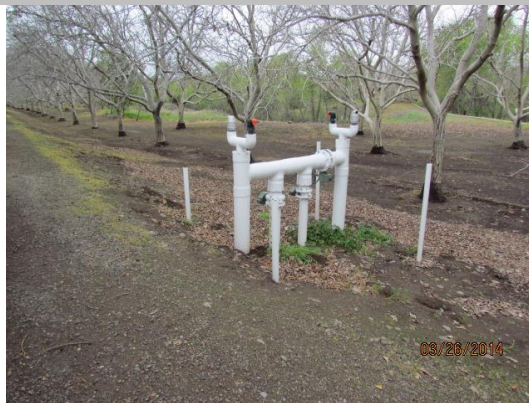
Photo 1 of 1 : rduffey_s_20140428_224.jpg

View of the irrigation pipe along the waterside slope.

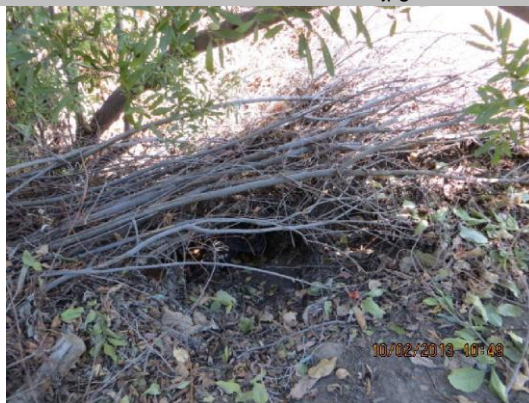
Photo 1 of 1 : UCIP_3278.jpg

Outlet covered by tree trimmings.

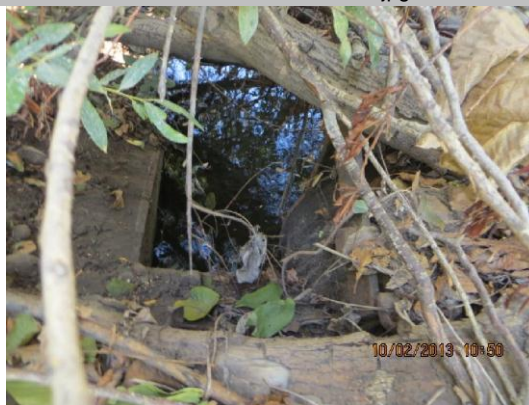
Photo 1 of 1 : UCIP_3276.jpg

Concrete U-shaped headwall and flapgate at WS toe.

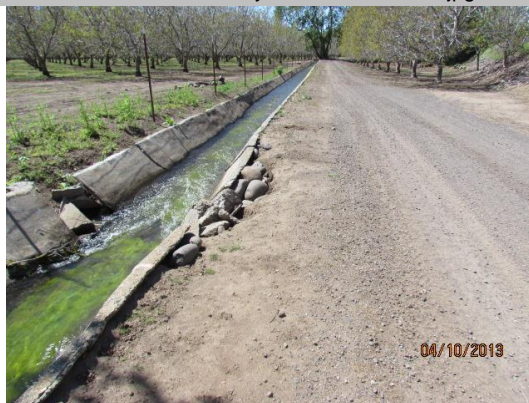
Photo 1 of 1 : rduffey_s_20140304_604.jpg

View of the erosion along the landside slope.

| Note and monitor erosion site. | | | | | |

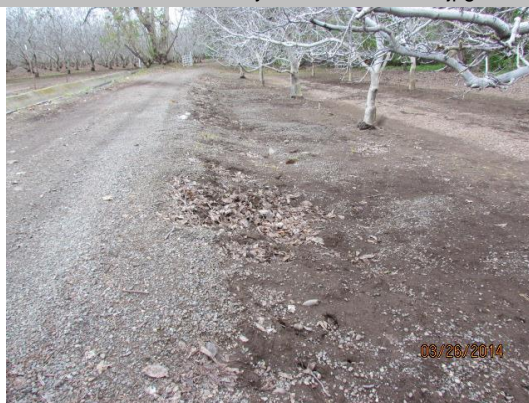
Photo 1 of 1 : rduffey_s_20140428_225.jpg

View of the erosion along the waterside slope.

| Repair slope instability. | | | | | |

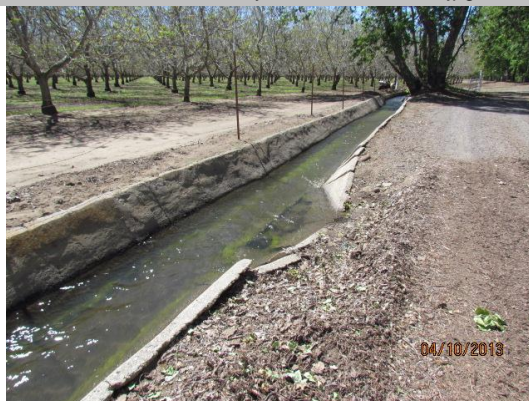
Photo 1 of 1 : rduffey_s_20140304_605.jpg

View of the erosion along the landside slope.

| Note and monitor erosion site. | | | | | |

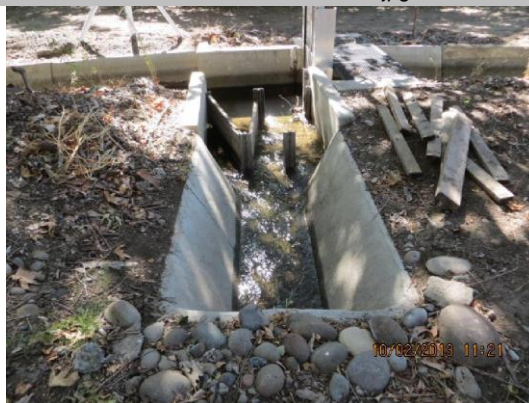
Photo 1 of 1 : UCIP_3281.jpg

Concrete canal/distribution box on LS shoulder.

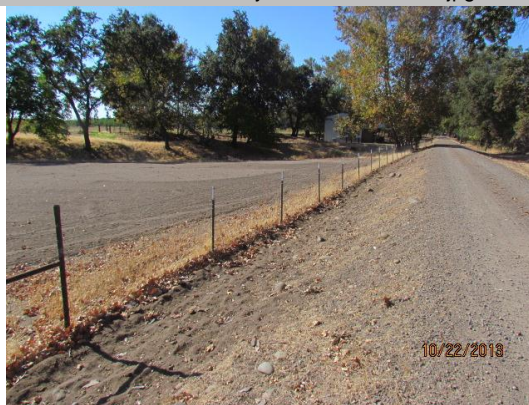
Photo 1 of 1 : rduffey_s_20140304_607.jpg

View of the erosion cause from livestock on both slope of the levee.

| Repair the levee slope damaged by livestock and prevent large animal access. | | | | | |

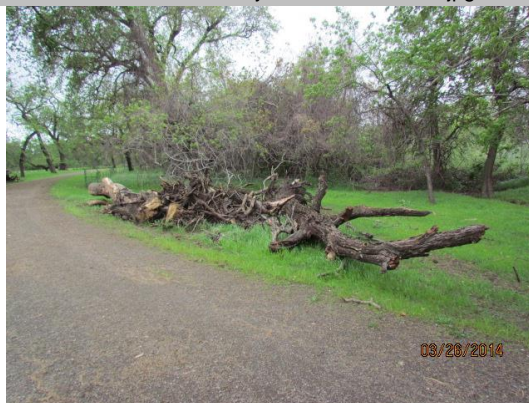
Photo 1 of 1 : rduffey_s_20140428_226.jpg

View of the trees limbs along the waterside toe.

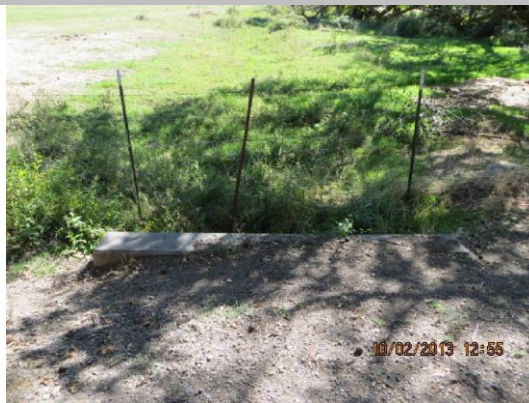
Photo 1 of 1 : UCIP_2750.jpg

Concrete headwall on LS toe.

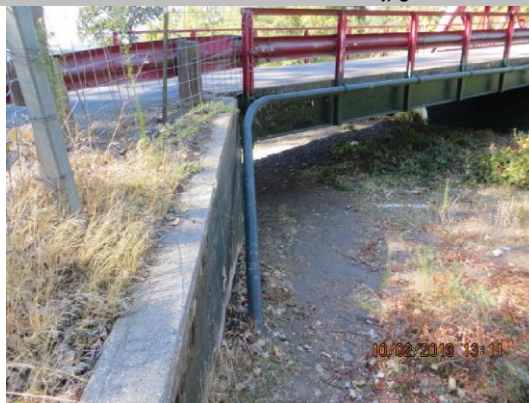
Photo 1 of 1 : UCIP_3283.jpg

Conduit visible on WS slope and at upstream side of bridge.

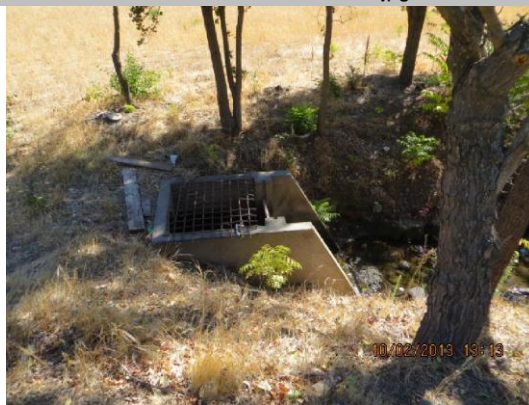
Photo 1 of 1 : UCIP_2752.jpg

| UCIP Comments: Flapgate missing or burried on WS toe. Pipe partially blocked by soil on WS toe. | | | | | |

Concrete control structure on LS toe.

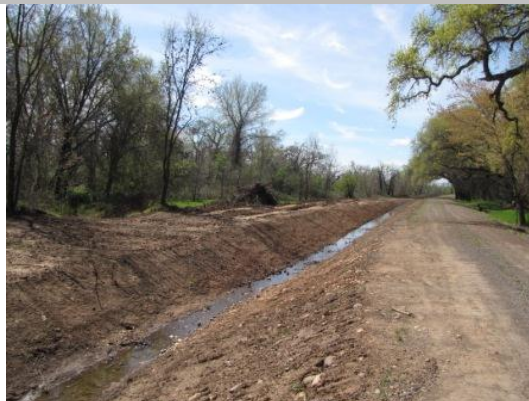
Photo 1 of 1 : rduffey_s_20140304_595.jpg

Remove agricultural ditch from toe of levee.

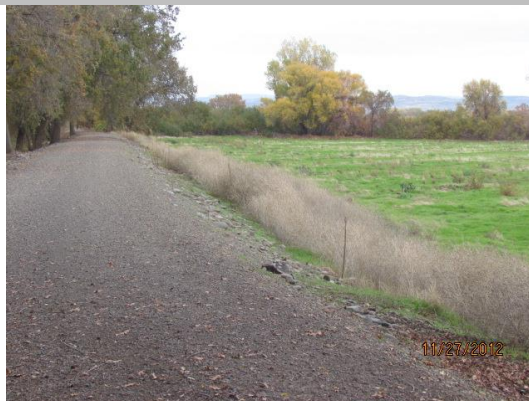
Photo 1 of 1 : rduffey_s_20140304_596.jpg

View of the vegetation along the landside slope.

| Remove the wild growth other than native grasses from the levee slopes. | | | | | |

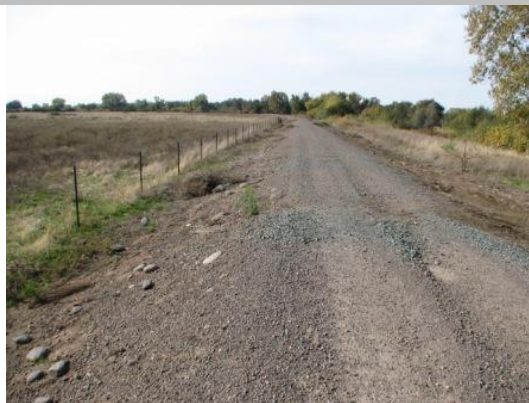
Photo 1 of 1 : rduffey_s_20140304_597.jpg

Erosion on crown and both slopes.

| Repair the levee slope damaged by foot traffic and prevent access where possible. | | | | | |

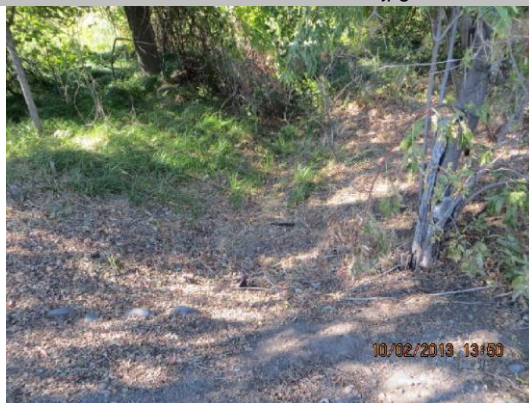
Photo 1 of 1 : UCIP_3243.jpg

Flapgate blocked by soil and debris.

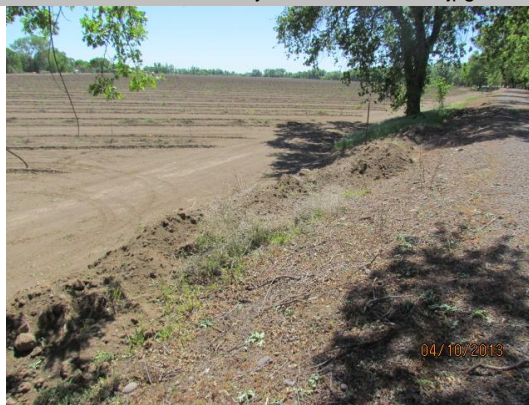
Photo 1 of 1 : rduffey_s_20140304_606.jpg

View of the erosion along the landside slope.

| Repair slope instability. | | | | | |

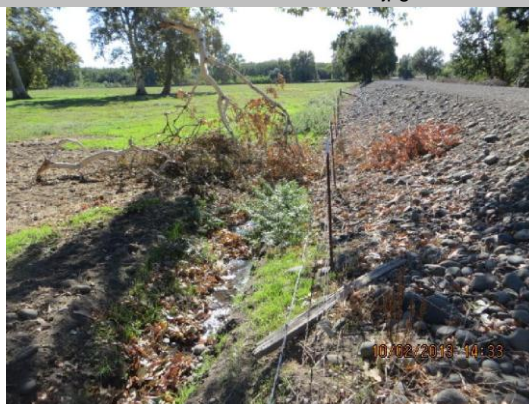
Photo 1 of 1 : UCIP_3247.jpg

Low spot on LS toe where water dissapears from levee toe. Unable to identify exact location of pipe on LS toe.

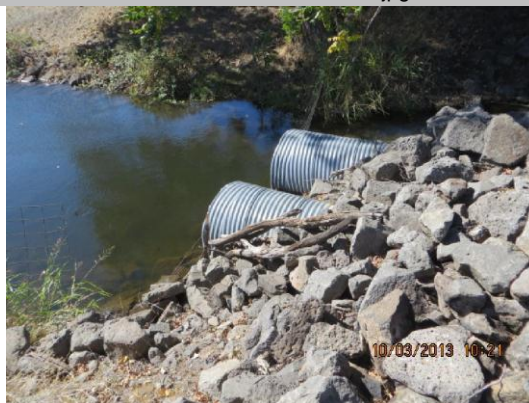
Photo 1 of 1 : UCIP_3288.jpg

Pipe visible on LS toe.

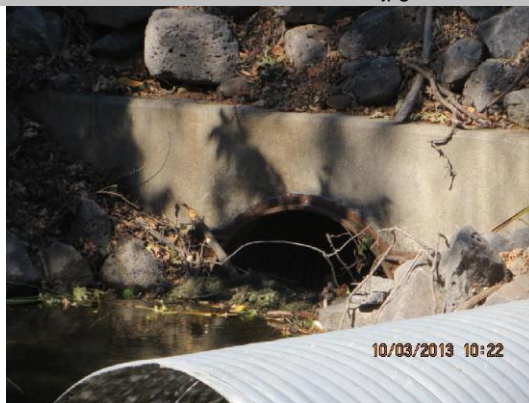
Photo 1 of 1 : UCIP_3294.jpg

Pipe visible at headwall on LS toe.

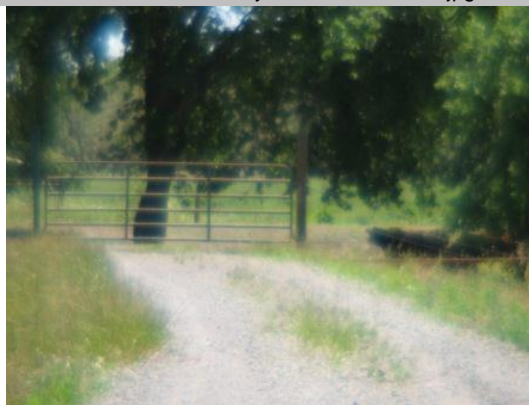
Photo 1 of 1 : rduffey_s_20140304_598.jpg

View of the non-permitted gate on the crown of the levee.

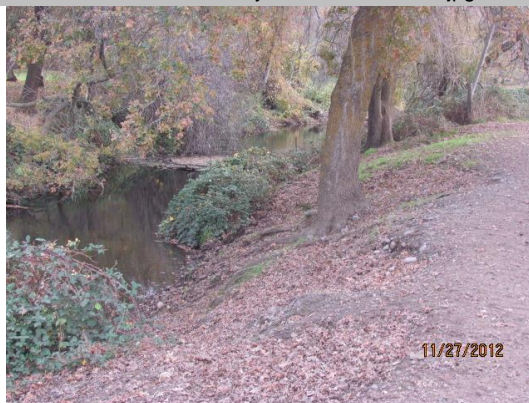
Photo 1 of 1 : rduffey_s_20140304_601.jpg

View of the erosion caused by livestock along the landside slope.

| Repair slope instability. | | | | | |

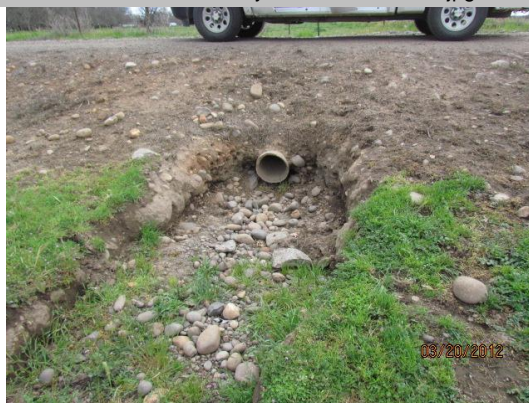
Photo 1 of 1 : rduffey_s_20140304_600.jpg

| Inspector Comments: No flapgate on pipe. | | | | | |

No flap gate on 18 inch pipe going to the levee.

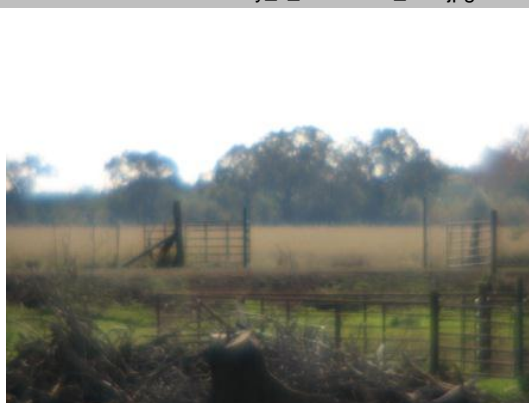
Photo 1 of 1 : rduffey_s_20140304_599.jpg

View of the non-permitted gate on the crown roadway.

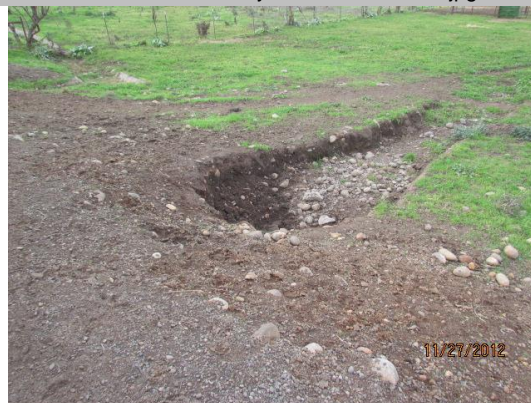
Photo 1 of 1 : rduffey_s_20140304_602.jpg

View of the ditch along the waterside toe.

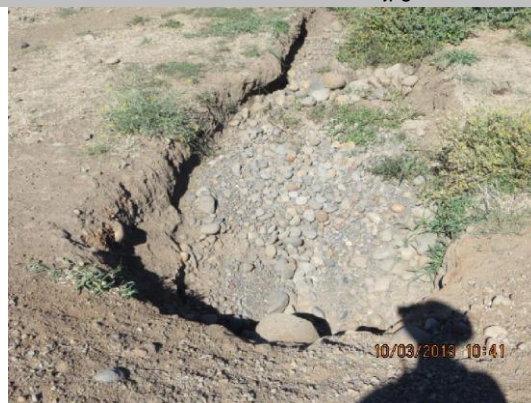
Photo 1 of 1 : UCIP_3336.jpg

Concrete pipe at outlet on WS toe.

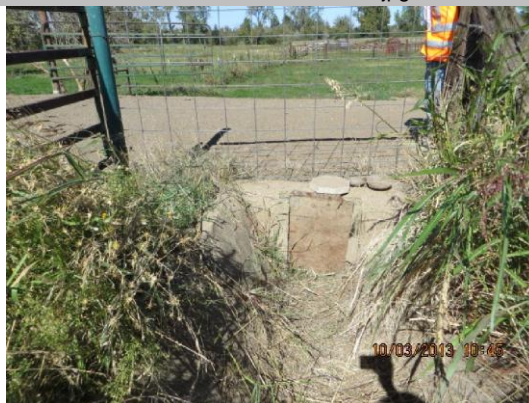
Photo 1 of 1 : UCIP_3334.jpg

Slide panel at inlet on LS shoulder.

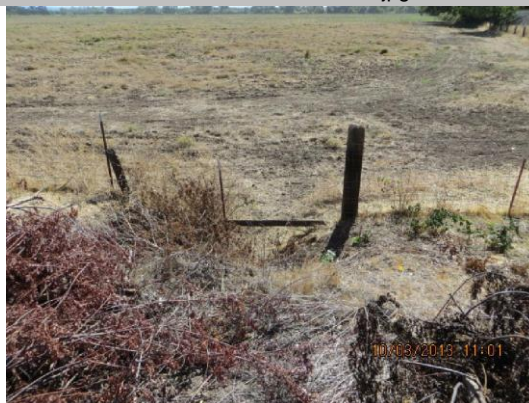
Photo 1 of 1 : UCIP_2757.jpg

| UCIP Comments: Gate missing from WS toe. | | | | | |

Inlet on LS toe.

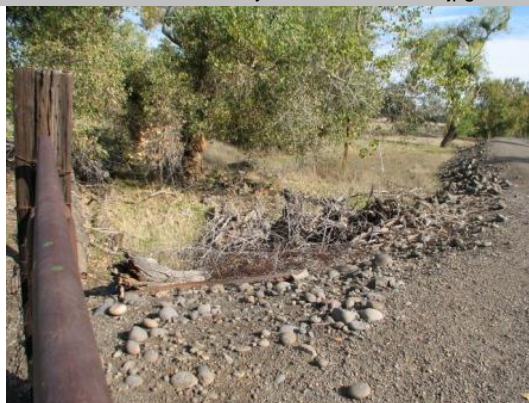
Photo 1 of 1 : rduffey_s_20140304_619.jpg

View of debris & wire at toe of levee.

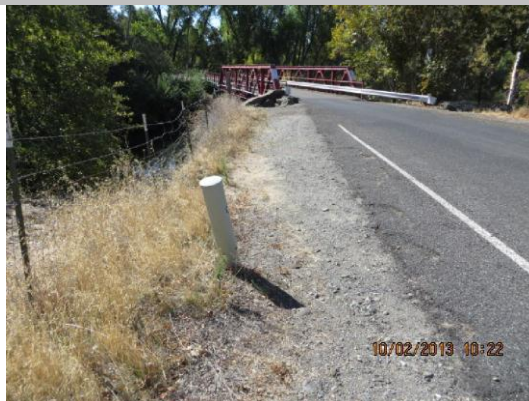
Photo 1 of 1 : UCIP_3275.jpg

Communication line access box on WS shoulder.

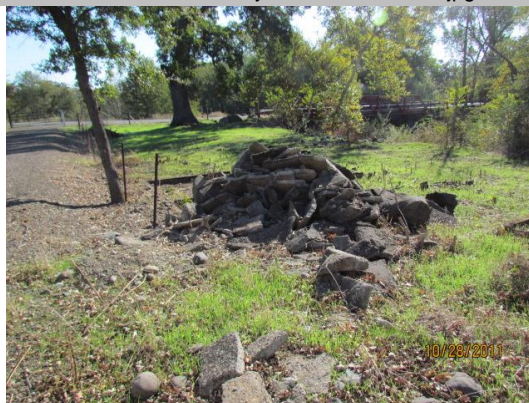
Photo 1 of 1 : rduffey_s_20140304_621.jpg

View of the concrete pile along the W/S toe.

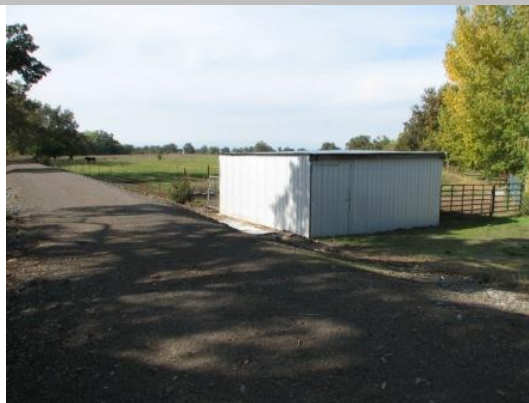
Photo 1 of 1 : rduffey_s_20140304_623.jpg

View of building at toe of levee.

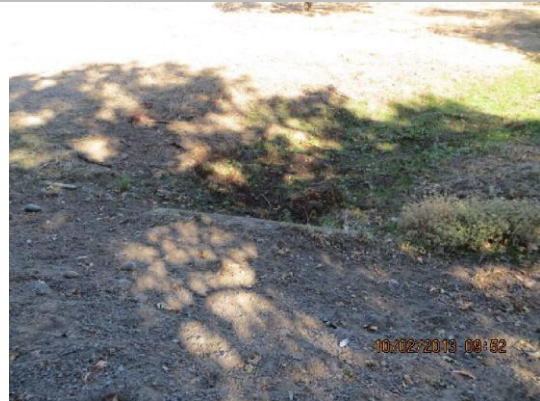
Photo 1 of 1 : UCIP_2747.jpg

Concrete headwall at LS toe.

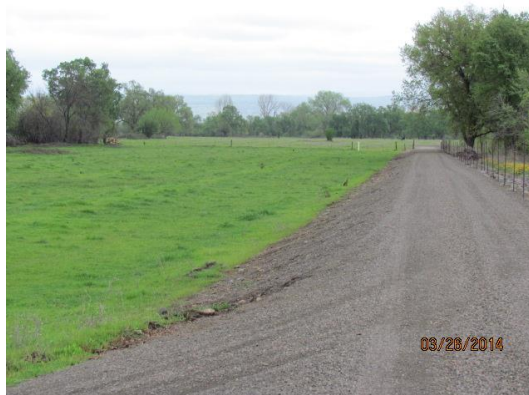
Photo 1 of 1 : rduffey_s_20140428_227.jpg

View of the levee with no grass growing on either slope.

| Control annual grass and weeds on the levee slopes and easements. | | | | | |

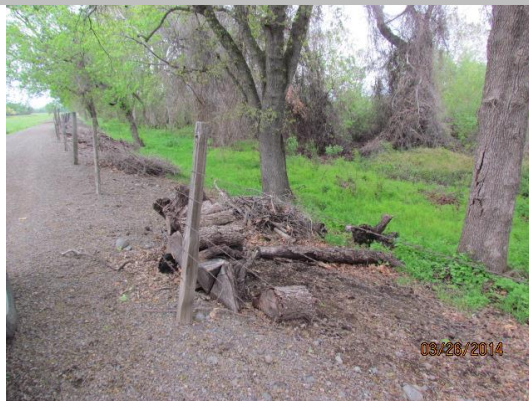
Photo 1 of 1 : rduffey_s_20140428_228.jpg

Remove all firewood from the waterside slope.

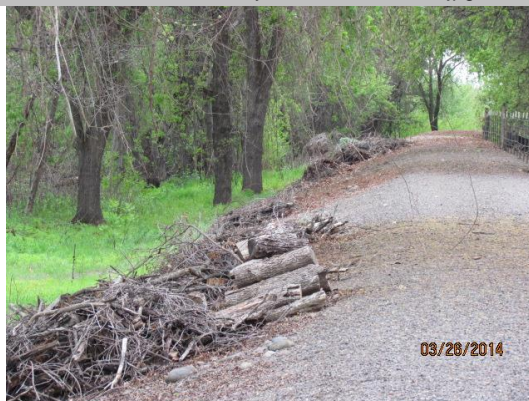
Photo 1 of 1 : rduffey_s_20140428_229.jpg

View of the debris along the waterside slope.

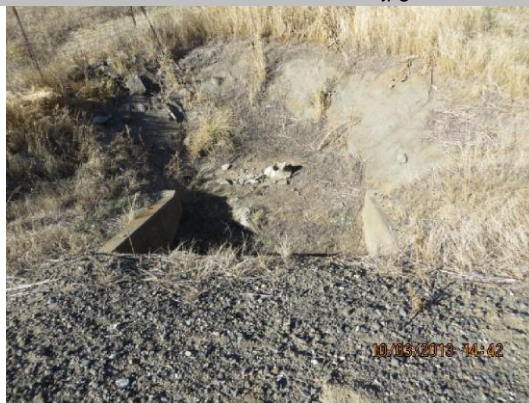
Photo 1 of 1 : UCIP_2770.jpg

Concrete U-shaped headwall on LS toe.

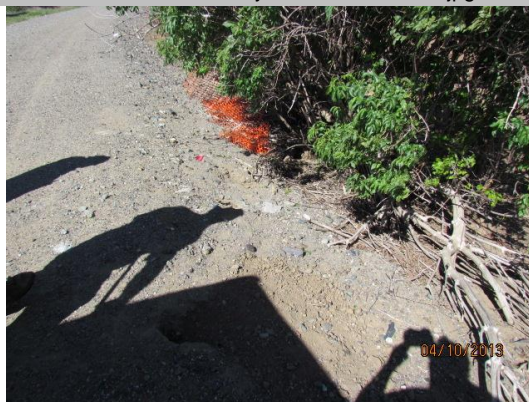
Photo 1 of 1 : rduffey_s_20140304_631.jpg

View of the rodent holes along the landside slope.

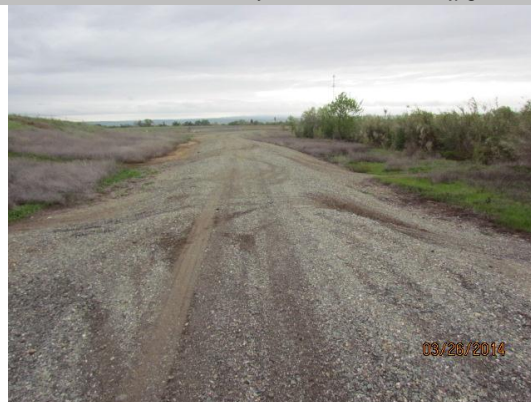
Photo 1 of 1 : rduffey_s_20140428_221.jpg

| Repair the levee slope damaged by vehicle traffic and prevent access where possible. Inspector Comments: Tehama Co. repaired the slope that was damaged by vehicle traffic, but the damage has returned. | | | | | |

View of the levee slope damaged by vehicle traffic.

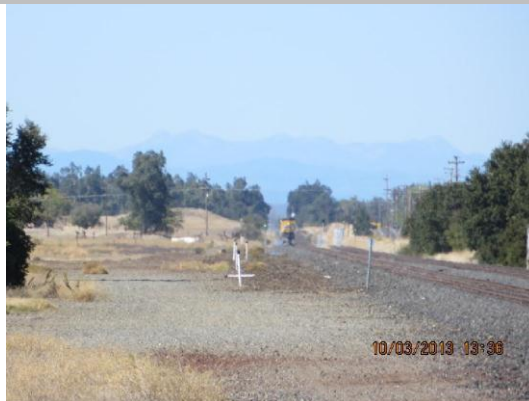
Photo 1 of 1 : UCIP_3305.jpg

Fiber optic line markers off LS shoulder.

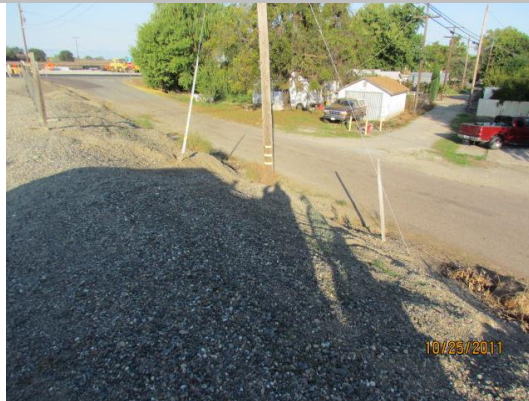
Photo 1 of 1 : rduffey_s_20140304_635.jpg

View of the vehicle erosion along the L/S slope.

| Repair the levee slope damaged by vehicle traffic and prevent access where possible. | | | | | |

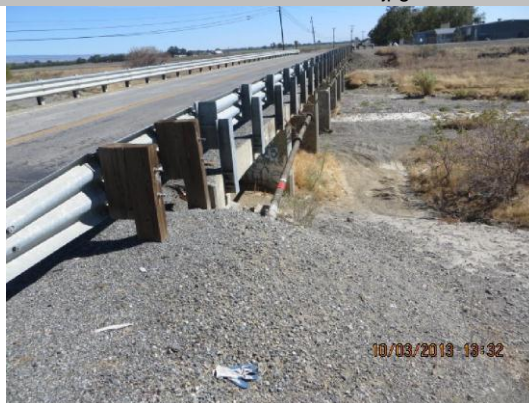
Photo 1 of 1 : UCIP_3304.jpg

Gasline on upstream side of bridge.

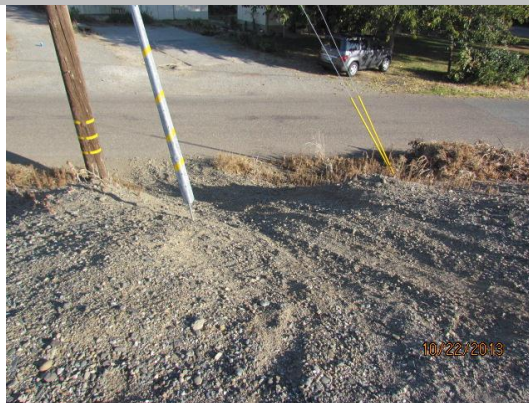
Photo 1 of 1 : rduffey_s_20140304_633.jpg

View of the vehicle erosion along the landside slope.

| Repair the levee slope damaged by vehicle traffic and prevent access where possible. | | | | | |

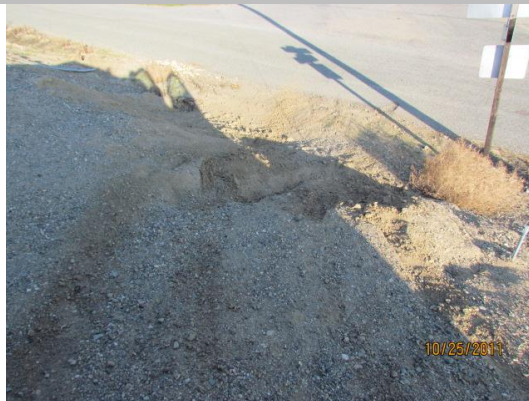
Photo 1 of 1 : rduffey_s_20140304_636.jpg

View of the vehicle erosion along the L/S slope.

| Repair the levee slope damaged by vehicle traffic and prevent access where possible. | | | | | |

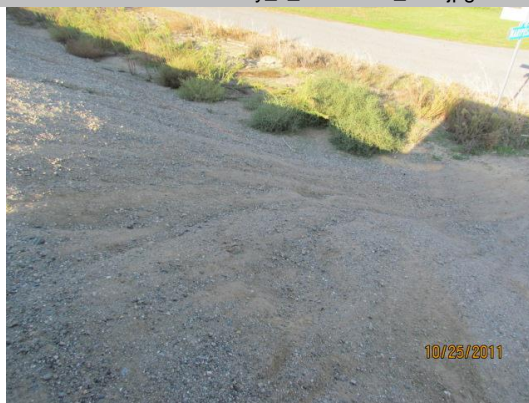
Photo 1 of 1 : rduffey_s_20140304_627.jpg

View of the vehicle erosion along the L/S slope.

| Repair the levee slope damaged by vehicle traffic and prevent access where possible. | | | | | |

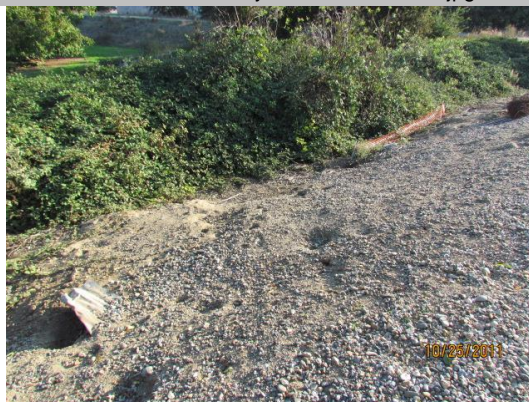
Photo 1 of 1 : rduffey_s_20140304_629.jpg

View of the rodent holes along the L/S slope.

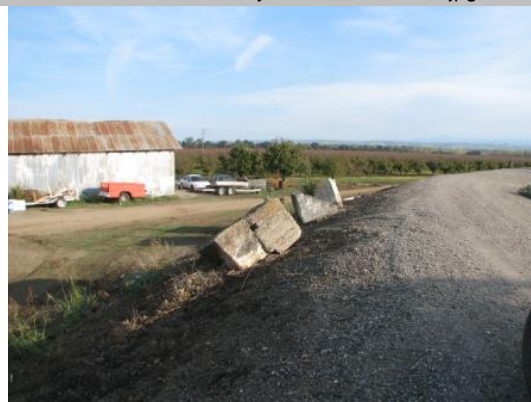
Photo 1 of 1 : rduffey_s_20140304_626.jpg

View of the concrete stairways on the slope.

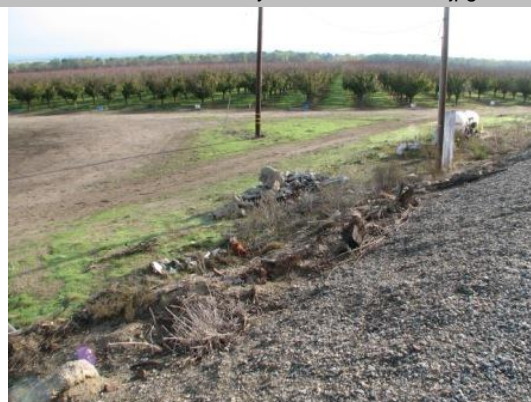
Photo 1 of 1 : rduffey_s_20140304_630.jpg

View of the garbage and metal at the toe of the levee & along the slope of the landside.

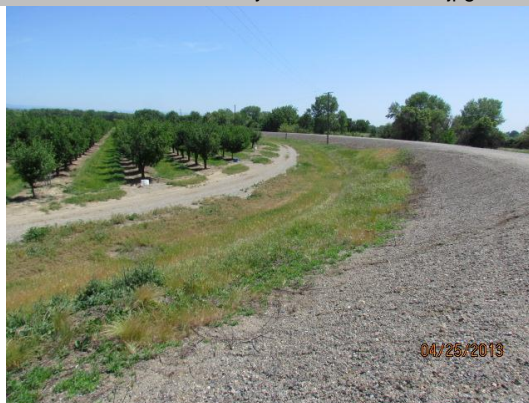
Photo 1 of 1 : rduffey_s_20140304_632.jpg

View of the ditch along landside toe.

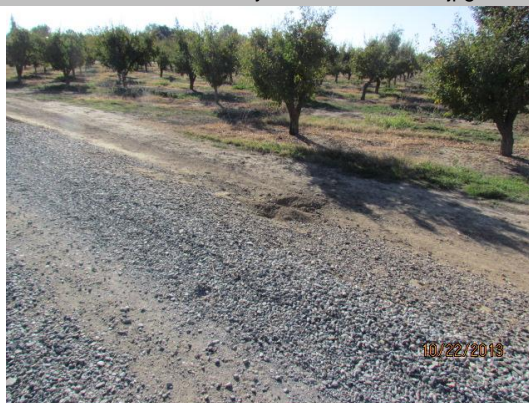
Photo 1 of 1 : rduffey_s_20140304_640.jpg

View of the rodent holes along the landside slope.

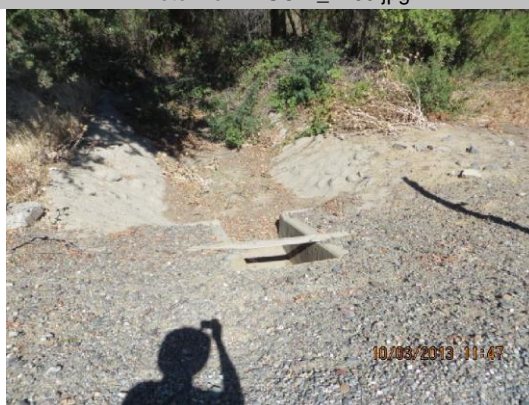
Photo 1 of 1 : UCIP_2760.jpg

Concrete headwall on WS toe.

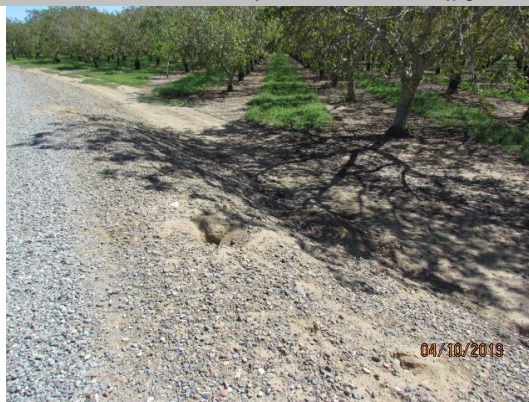
Photo 1 of 1 : rduffey_s_20140304_642.jpg

View of the rodent holes along the levee slope.

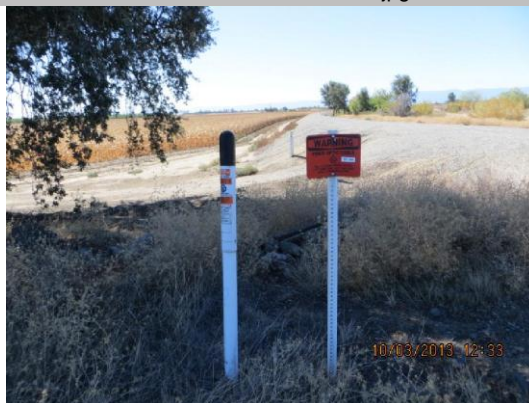
Photo 1 of 1 : UCIP_3307.jpg

Fiber optic line markers on LS shoulder.

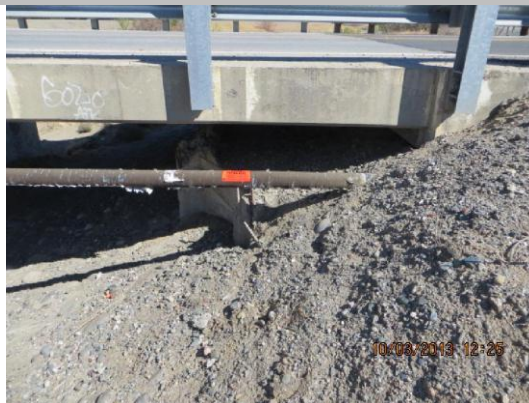
Photo 1 of 1 : UCIP_3302.jpg

Gasline on upstream side of bridge.

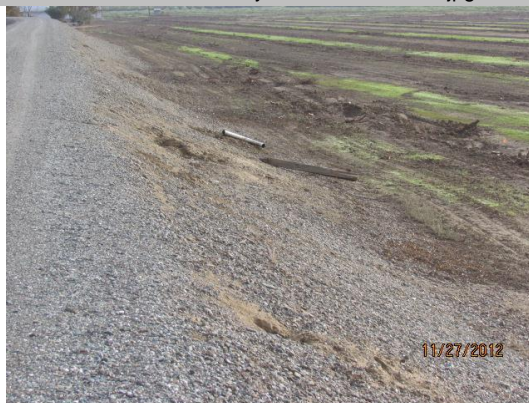
Photo 1 of 1 : rduffey_s_20140304_643.jpg

View of the rodent activity along the landside slope.

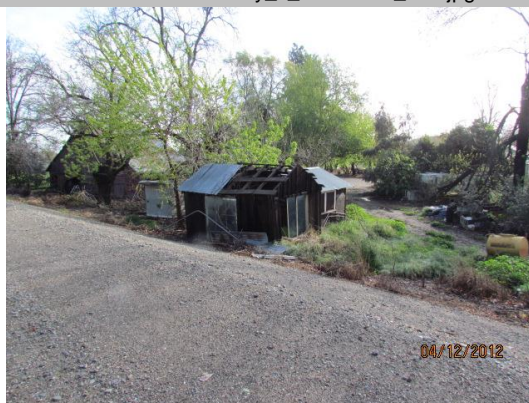
Photo 1 of 1 : rduffey_s_20140304_645.jpg

View of the bait station next to the squirrel holes on the landside slope.

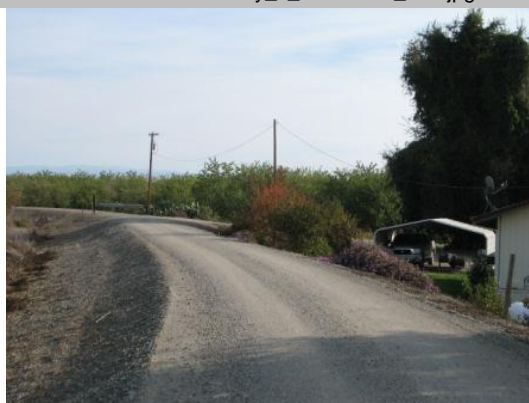
Photo 1 of 1 : rduffey_s_20140304_641.jpg

View of the landscape along the slope.

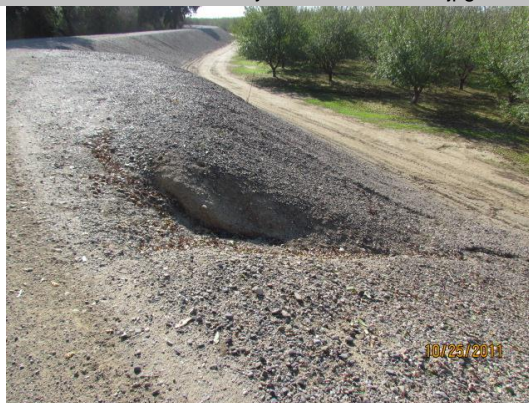
Photo 1 of 1 : rduffey_s_20140304_644.jpg

View of the erosion along the L/S slope.

| Schedule repair of erosion site prior to the next inspection. | | | | | |
